Manhole Inspection Summary

Manhole # S1900_009MH

Location Address: **2419 REISTERSTOWN-WOODROOK** Cross Street: **BRYANT AVE**

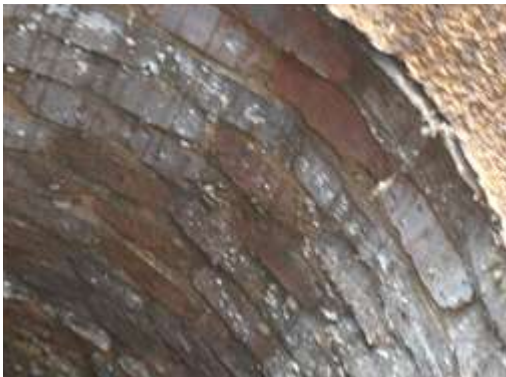
Defect 2

Debris of bench

surcharge evidence on steps

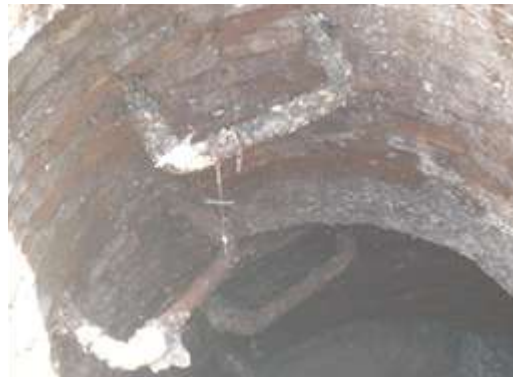
Defect 1

Steps Count: **3** Missing: **0** ☒ **Corroded**

Surcharge ☒ **Evidence Of Surcharge** Depth: **5** (ft.) ☐ Active Surcharge Present

corroded steps

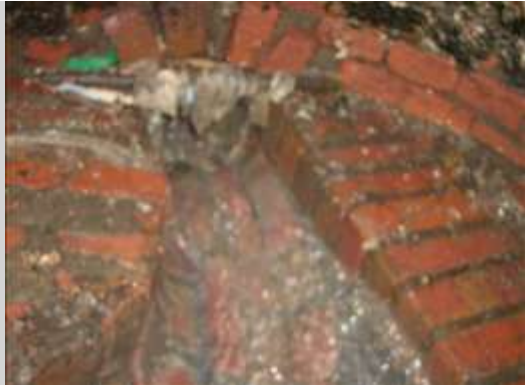
12 O'Clock Outflow

8 in. Circular Gravity Sewer
Pipe Out @ 12 O'Clock

Invert Depth: **8.21** (ft.) Flow Characteristics: **Slow**

Infiltration: **None** Pipe Seal Cond: **Sound**

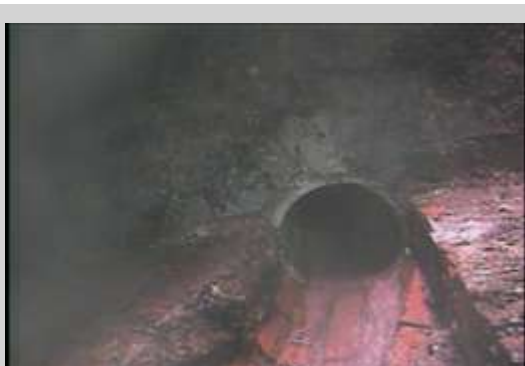
9 O'Clock Inflow

8 in. Circular Gravity Sewer
Pipe In @ 3 O'Clock

Invert Depth: **7.47** (ft.) Flow Characteristics: **Slow**

Infiltration: **None** Pipe Seal Cond: **Sound**
